CERTIFICATE OF APPROPRIATENESS

Property: 412 Main Street Tracts 2A and 3A, Block 44, SSBB Subdivision, City of Houston, Harris County, Texas. The site includes a 13-story steel frame building situated on a 4,626 square foot lot.

Proposal: Alteration – Remove the existing historic, heavily damaged cornice above the 12th floor and replace it with smooth EIFS scored to look like masonry.

412 MAIN BUILDING EAST PARAPET REPAIR

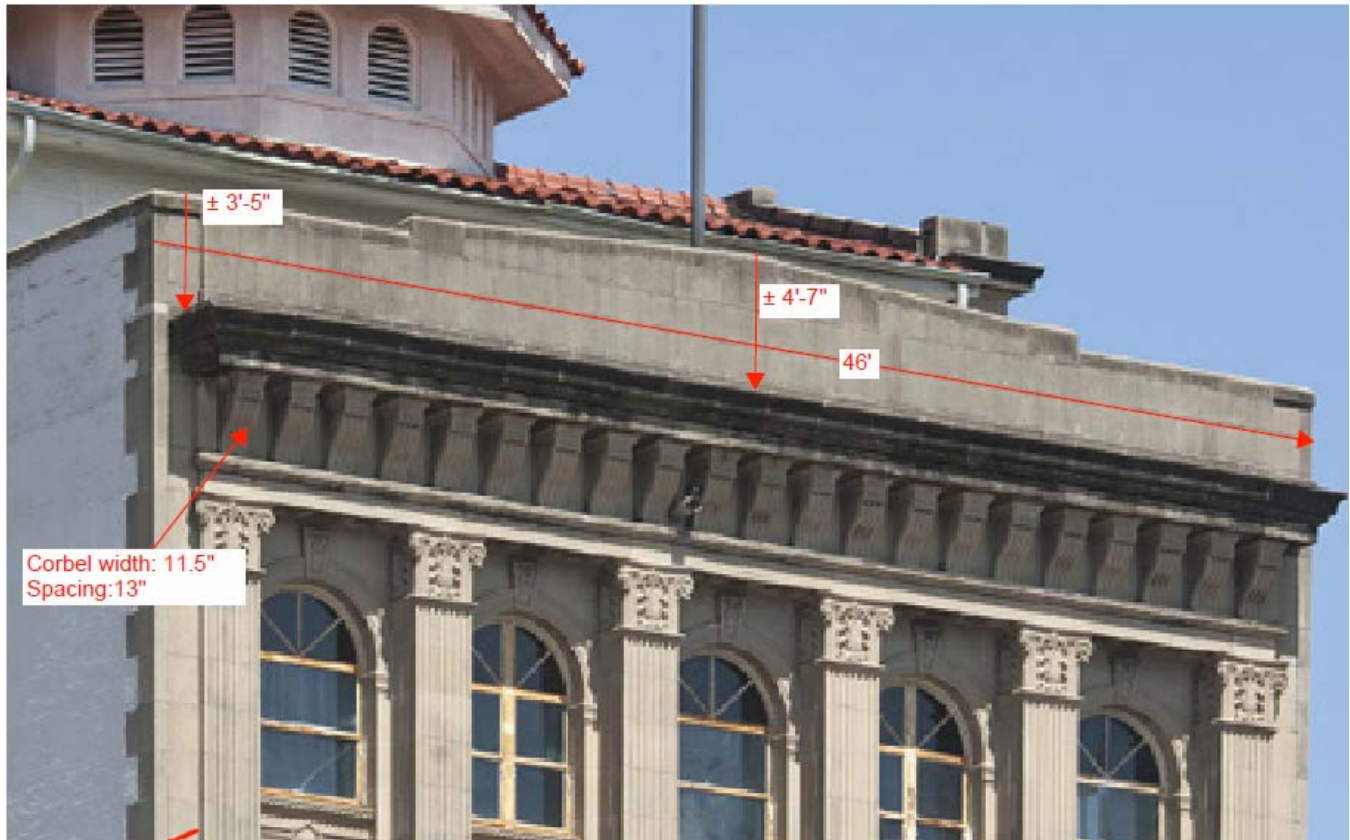
EXISTING

Front Elevation: The alteration removes an approximately 8' to 9'-5" tall section of damaged stone cornice and
(East) replace with smooth EIFS scored to look like masonry.

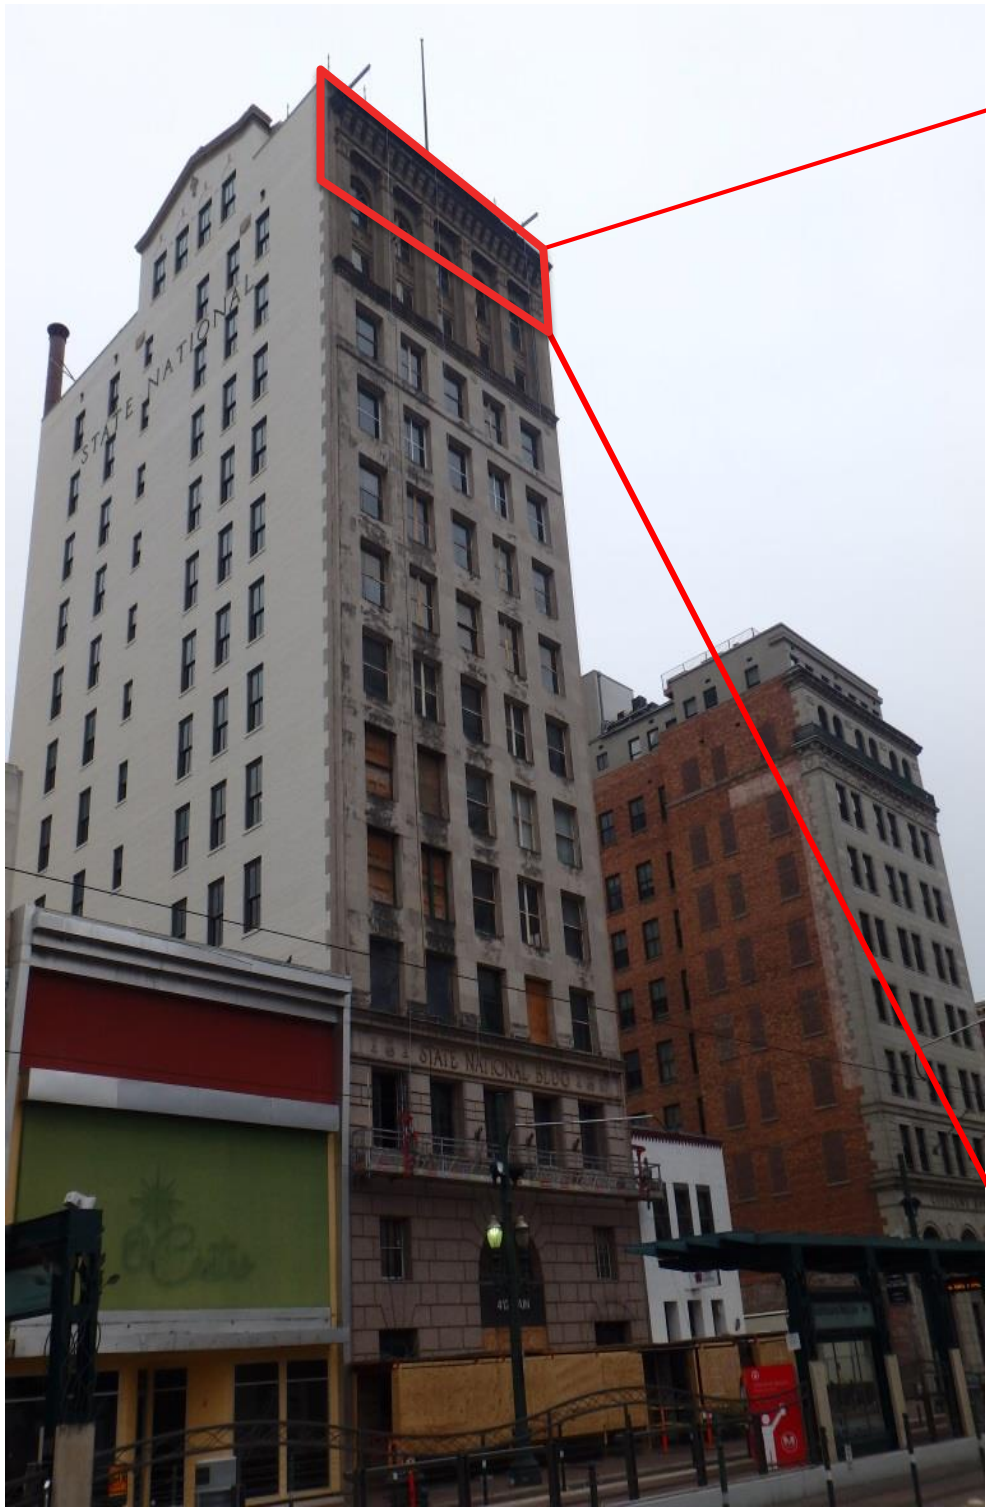
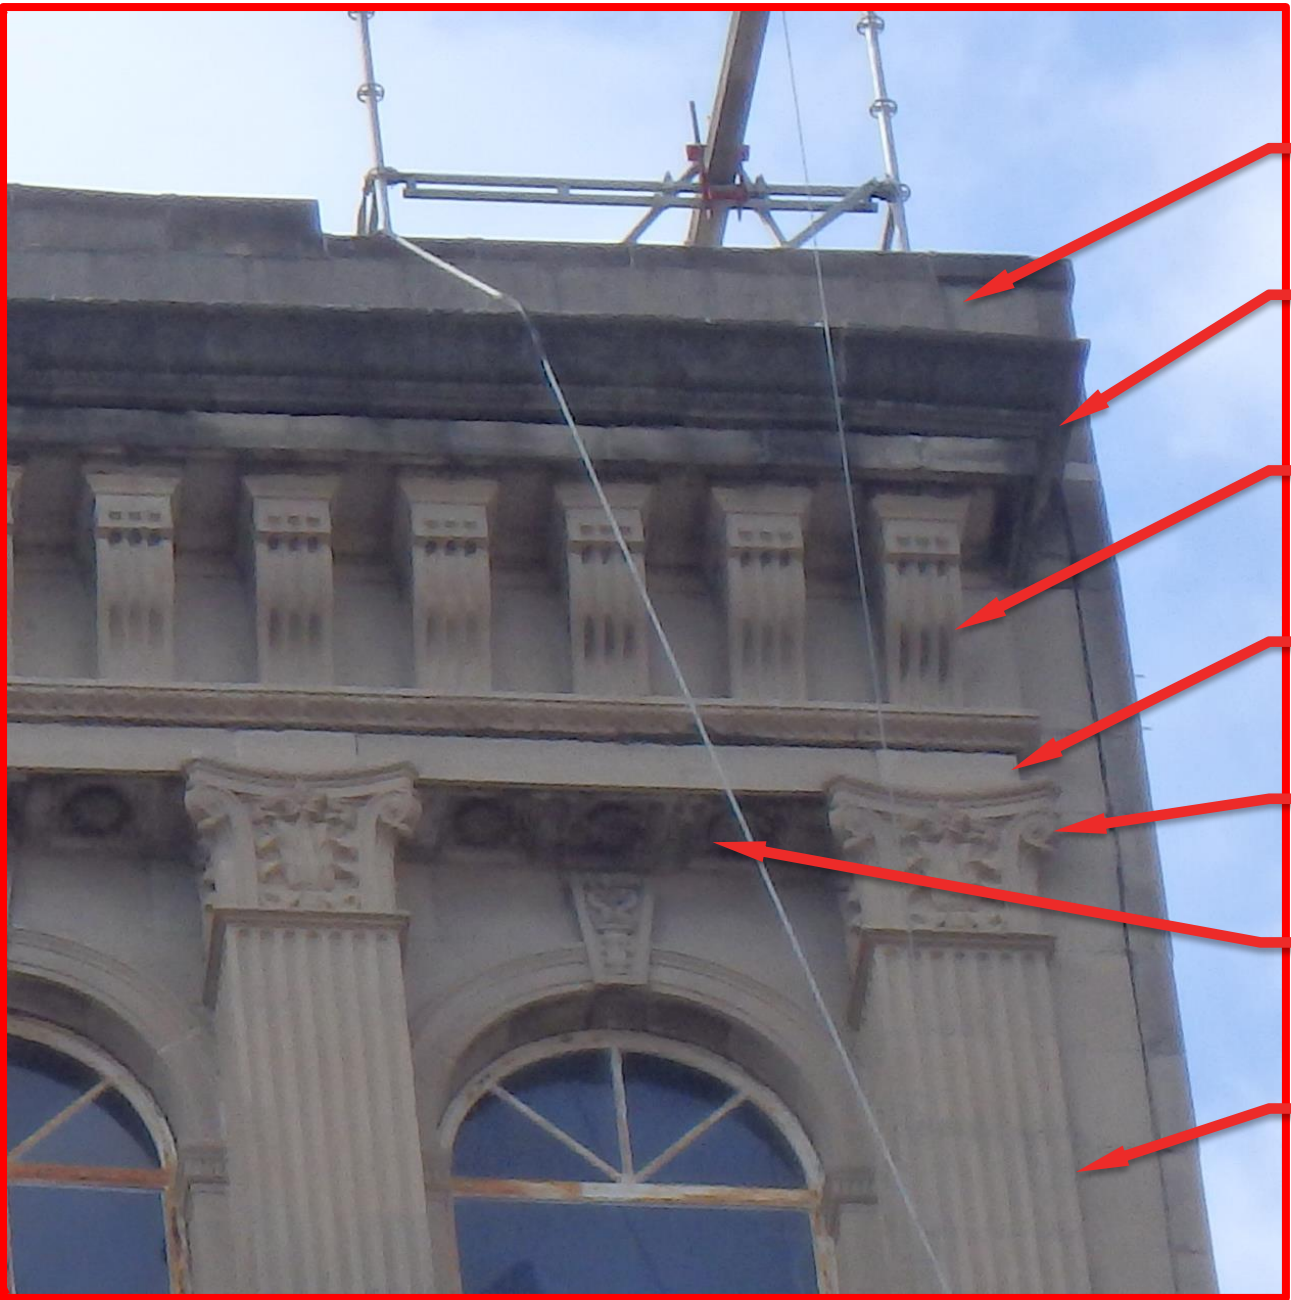
Parapet Construction

- Upper cornice cast stone pieces generally exhibiting displacement and mortar joint separation, likely due to corrosion-related expansion stresses.
- Most significant distress conditions were observed at the eastern and western upper corner cast stone members.

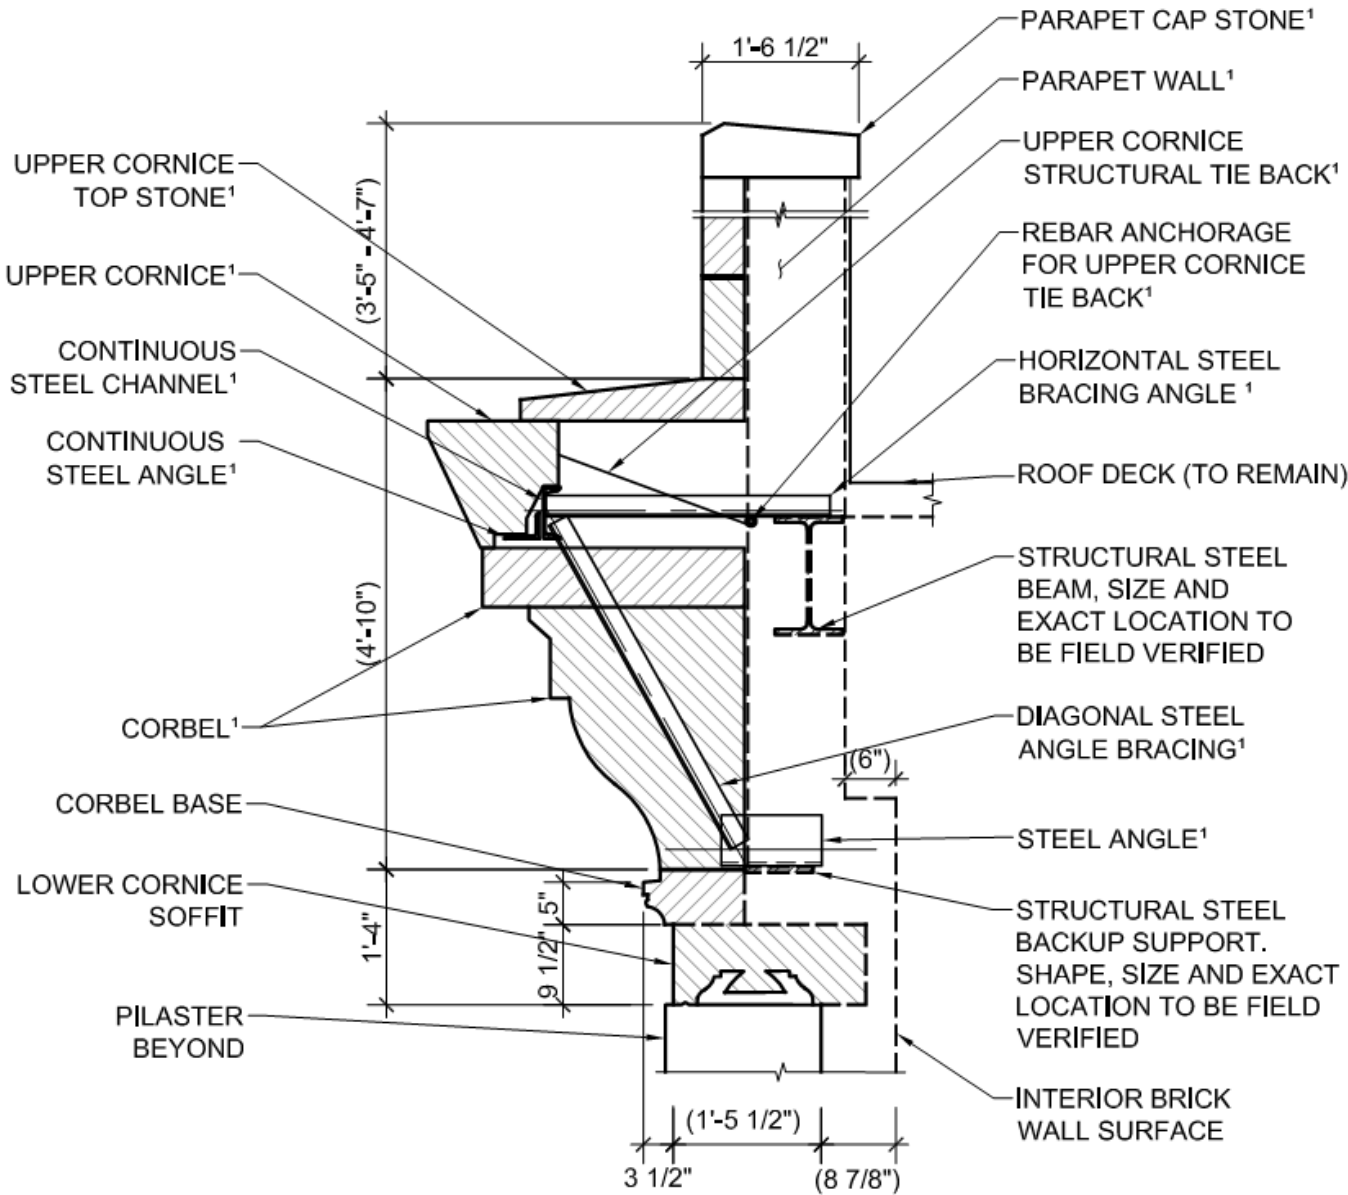
EXISTING FRONT WALL SECTION,
SCHEMATICALLY SHOWN

NOTES: 1. THIS ITEM TO BE REMOVED AND DISCARDED.
